# Manhole Inspection Summary

Manhole # S33E\_\_001MH

Insp Date: **8/4/08 9:16 AM**

**Location** Address: **39 w lexington st**

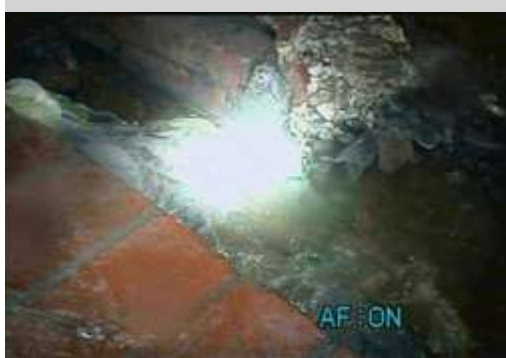
Defect 3

Condition: ☐ Sound ☐ Cracked ☐ Root Intrusion ☐ Deteriorated ☐ Leaks ☒ **Debris**

channel debris

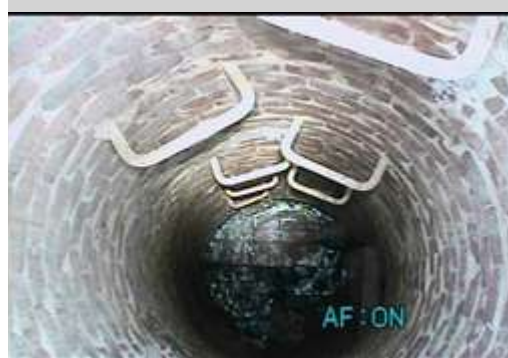
Defect 2

Count: **10** Missing: **0** ☒ **Corroded**

steps

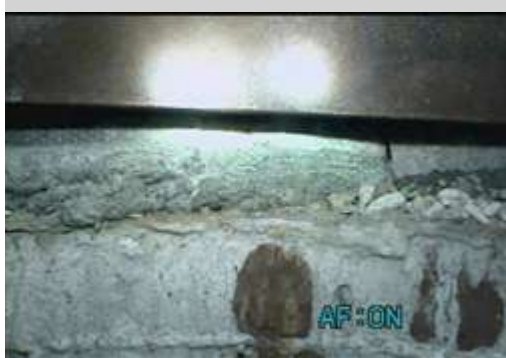
Defect 1

Condition: ☐ Sound ☐ Cracked ☐ Root Intrusion ☒ **Loose Brick** ☒ **Deteriorated**

chimney loose bricks, deteriorated

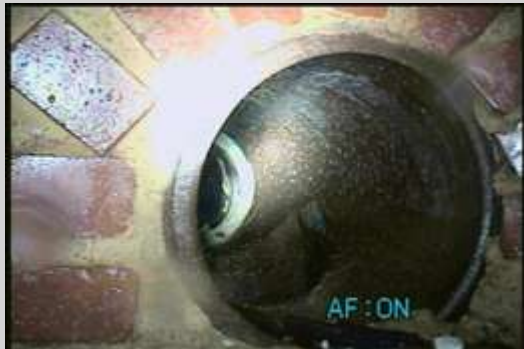
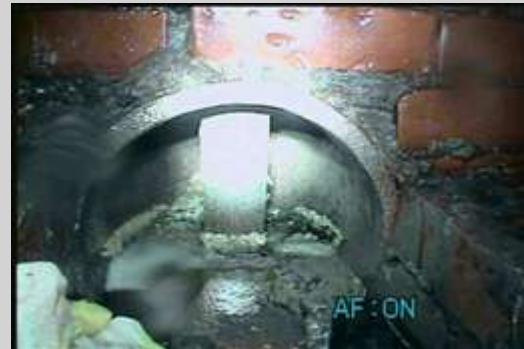
6 O'Clock Inflow

Deposits: ☐ None ☐ Mud ☐ Sludge ☐ Debris ☒ Grease

Drop: **Outside** **Direct**

Drop Condition: **Open**
